# 3 Current flood risks and management

## 3.1 History of flooding

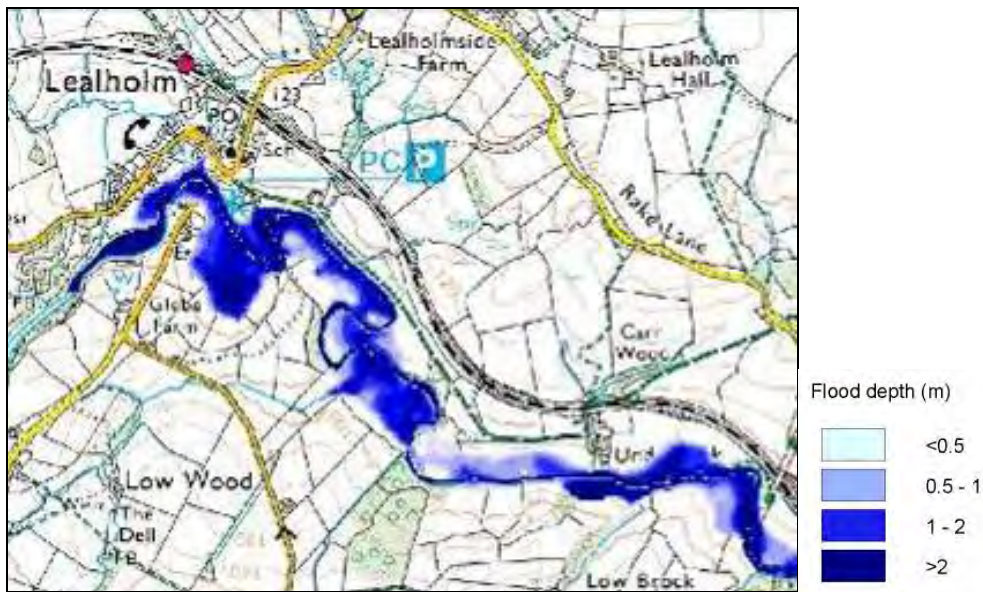
Figure 3.1 – Flood depth at Lealholm (1 per cent annual occurrence, assuming no defences)

At Lealholm the river flattens out making the banks an area naturally at risk from flooding and just upstream of Lealholm lies Crunkly Gill, a short 1km section of deep, narrow wooded gorge. The village has a bridge downstream which is prone to blockage during large floods due to its proximity to woodland. The local chapel pays homage to the flood events which have inundated it in 1840, 1930 and most recently in November 2000.

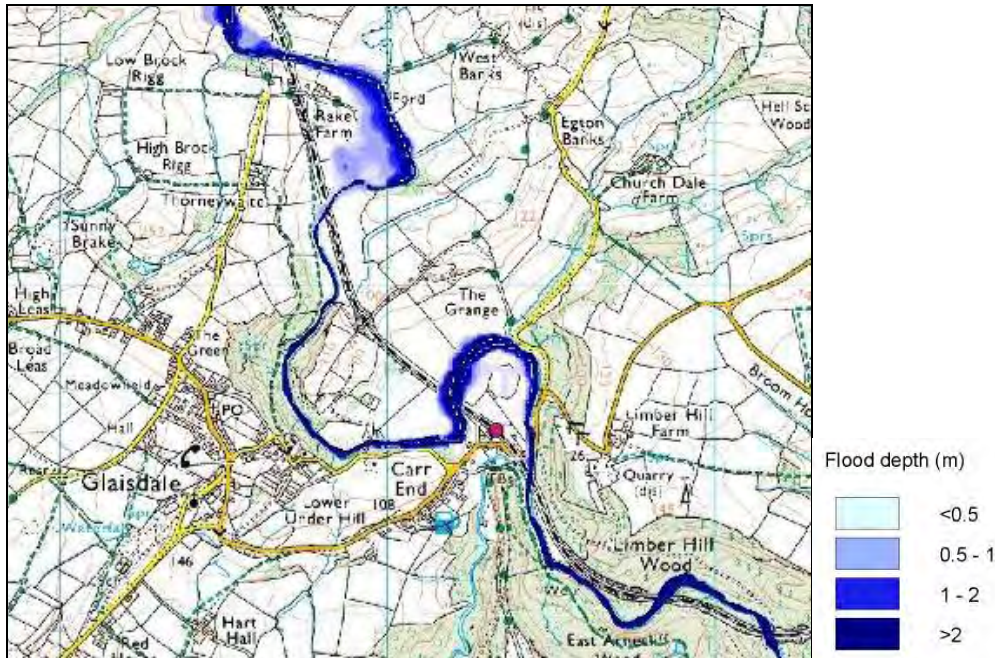
Figure 3.3 – Flood depth at Glaisdale (1 per cent annual occurrence assuming no defences)

Meandering through farmland the Esk passes two large railway bridges before entering a small wooded area adjacent to the raised settlement of Glaisdale. A number of structures as well as Limber Hill and East Arnecliff Woods separate Glaisdale and Egton Bridge, where a number of low lying properties lie adjacent to the watercourse. Egton Bridge has a history of flooding having occurred on several occasions.

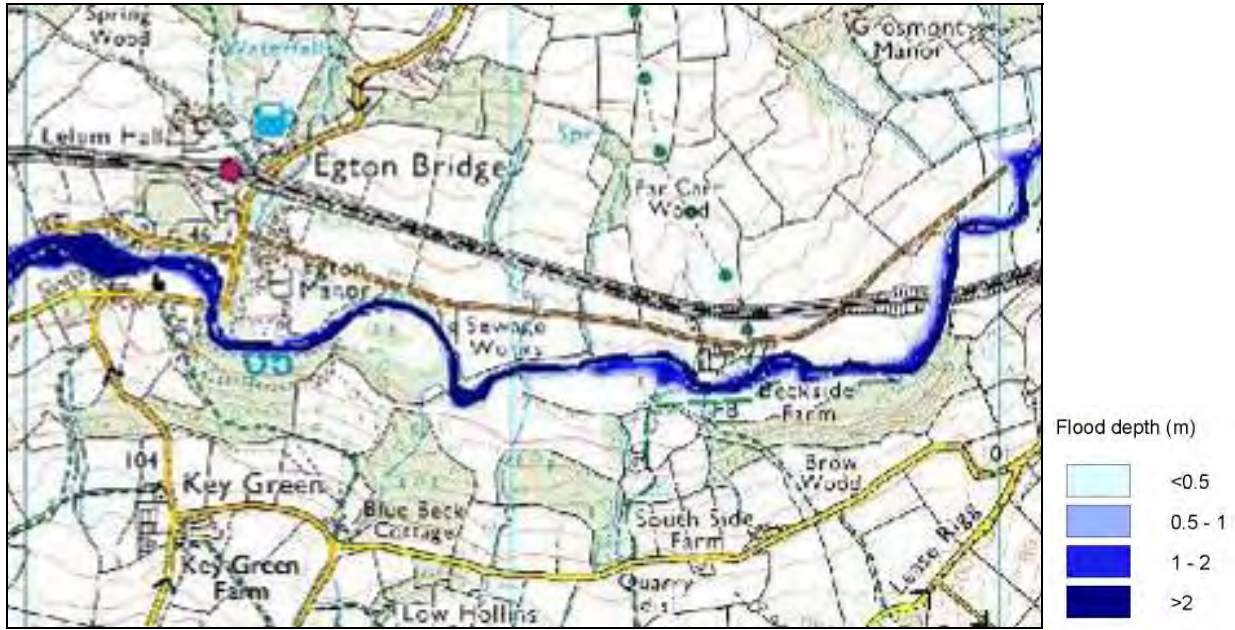
Figure 3.5 – Flood depth at Egton Bridge (1 per cent annual occurrence assuming no defences)
